EPRI Condenser Symposium 2011

A Case Study of the French Nuclear Power Industry Steam Surface Condenser Tubes Forty Years Later

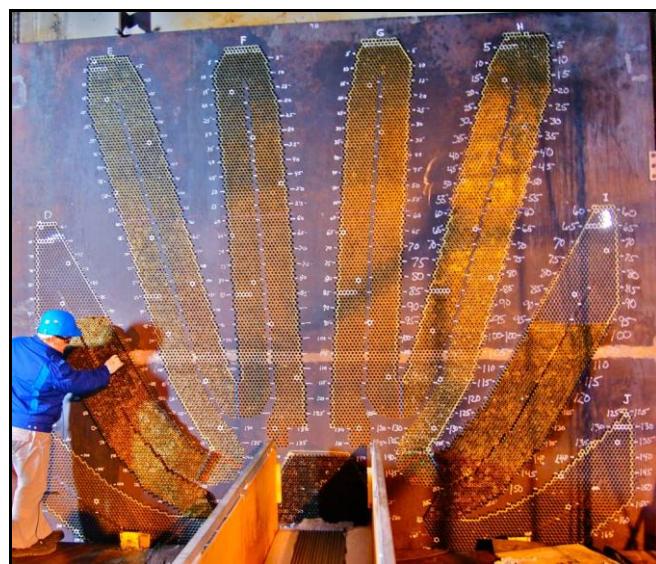
Figure 4: CP2 condenser tubesheet³

A typical CP2 condenser represents a minimum of 70,248 tubes (Figure 4). A single retubing operation represents anywhere from 35,000 (half a condenser) to 70,000+ tubes where all work must be performed during a maximum outage window. In order to complete all work during this schedule, 3 shifts of 60 to 80 persons (either 2x10h or 3x8h) are employed by the retubing company.

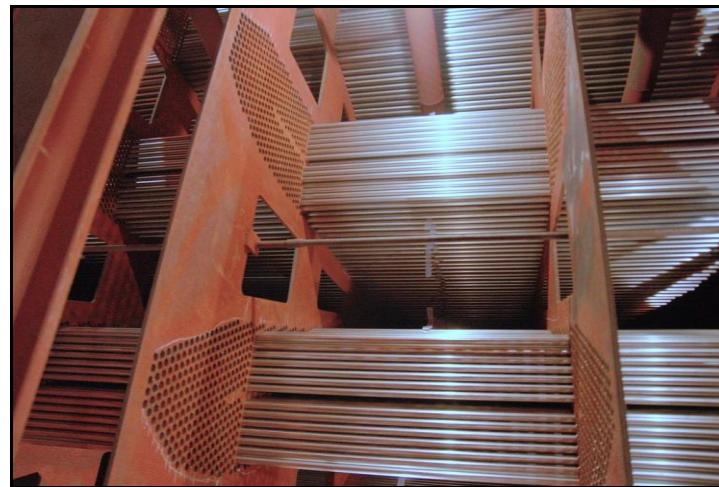
Figure 5: Open condenser view³

No 4: The condenser shall remain fully open including but not limited to man-holes and ingress and egress entry ways (figure 5). This practice has proven to be advantageous

allowing improved access facilitation, enhanced lighting, better aeration and improved safety issues relating to entry/exit, evacuation, etc.

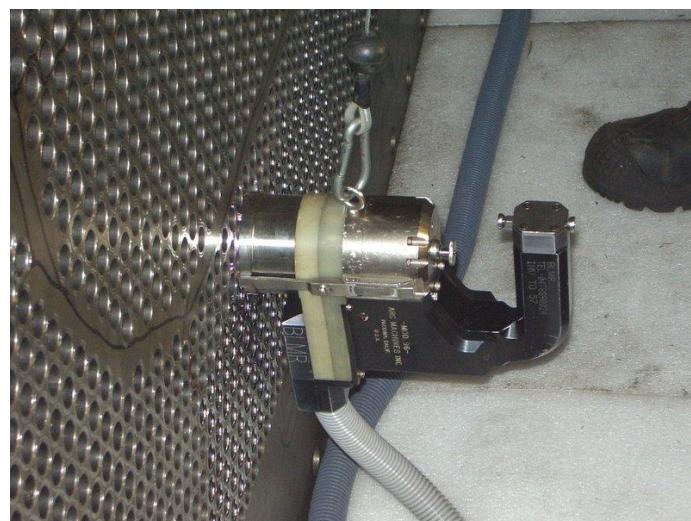
Figure 7: on-site orbital welding⁴

This tube-to-tube renovation was performed in 2010, on 1/6th of Cattenom 4. In total, 21,414 tubes of 18 mm OD, 0.5 and 0.7 mm wall, 13.75 m length were replaced (also in single compartment design). In addition, two tubesheets, and two water-boxes were coated. An innovative on-site, tube-to-tubesheet orbital weld procedure was a première event and gave a very good return of experiment. Tubes were in titanium Gr. 2 and plates were titanium clad carbon steel. A 100% die penetrant inspection of the welds on both tubesheets plus a final static hydro test validated the condenser leak tightness.
